**Cultural Resources Mitigation Plan for
Two Historic Hangars at the
Hamilton/Ravalli County Airport,
In Ravalli County, Montana.**

Cultural Resources Mitigation Plan for Two Historic Hangars
at the Hamilton/Ravalli County Airport,
Ravalli County, Montana.

Report Summary

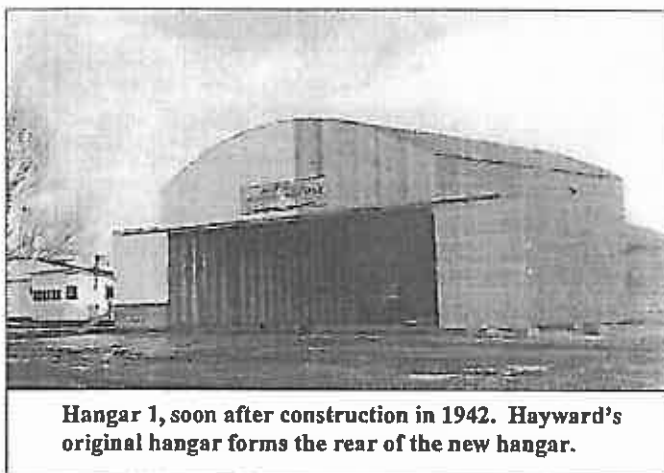
Hangar 1, soon after construction in 1942. Hayward’s original hangar forms the rear of the new hangar.

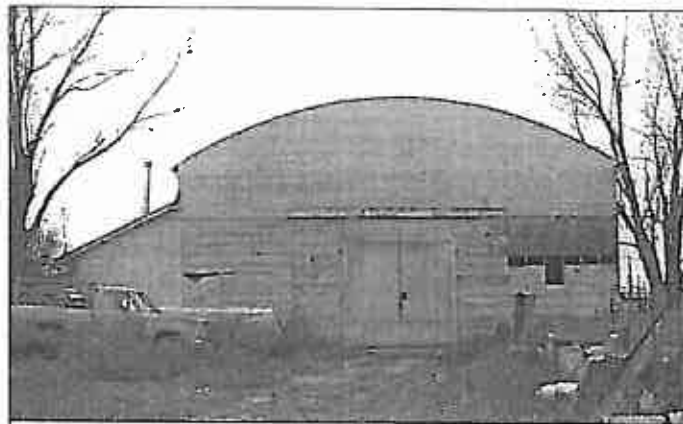
The deteriorated condition of Hangar 1 demonstrates the need for an HSR to guide future rehabilitation and reuse.

Creation of a Historic Structures Report (HSR) is a significant mitigation measure for the historic hangars, and will address building condition, later modifications, and structural considerations that will provide important baseline data for relocation planning and future rehabilitation. A qualified professional, such as an architect with a background in historic preservation or an historical architect, is recommended to prepare the HSR. An HSR is an invaluable reference tool that can be

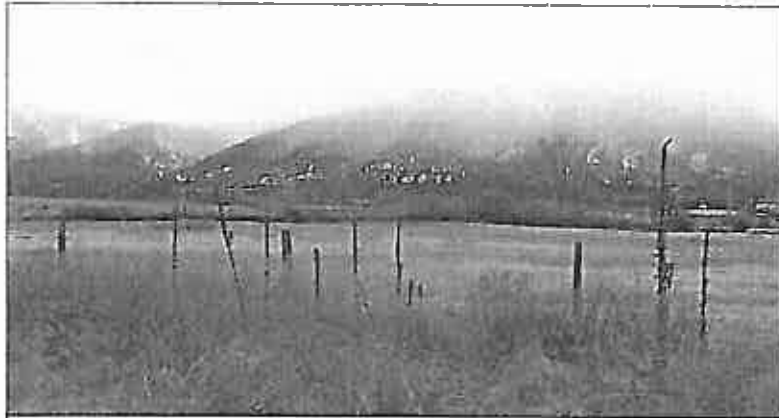
View from the current hangar site to the potential new hangar location approximately 200 yards to the west.

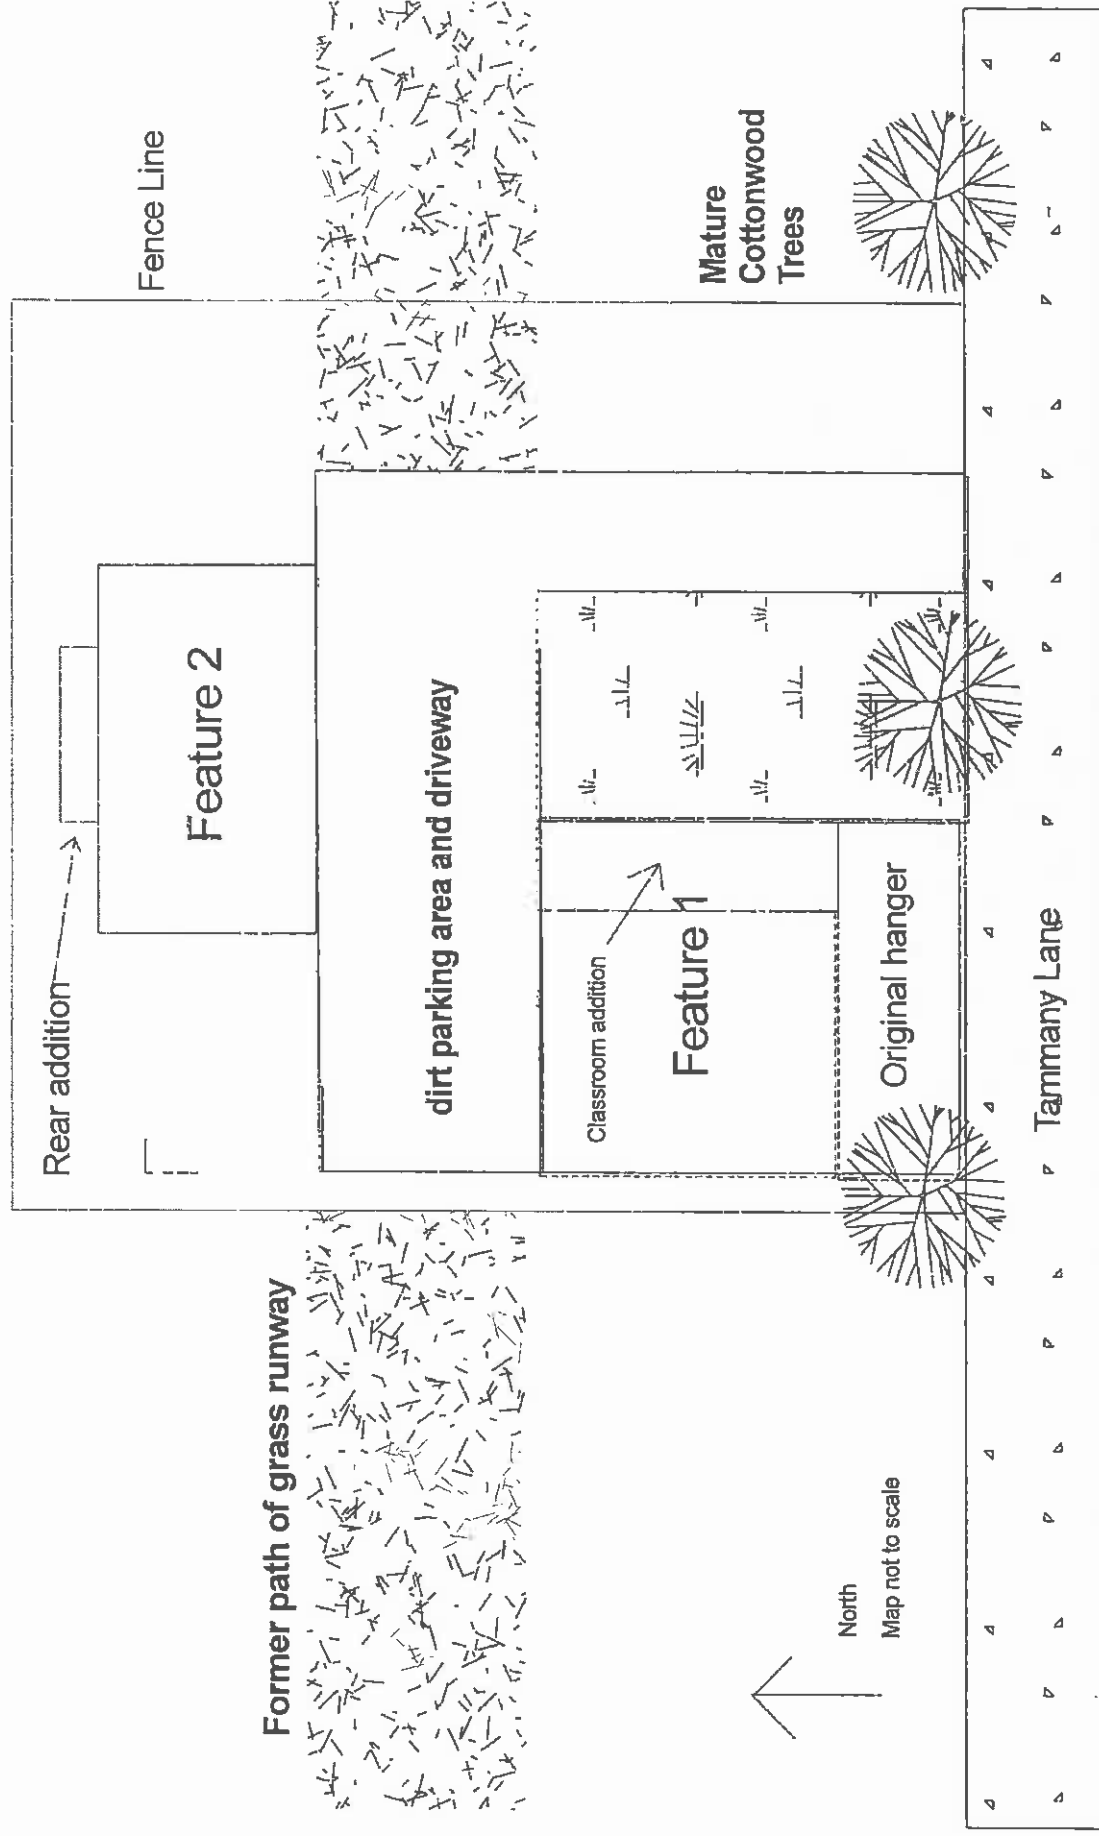
Site Plan Sketch Hayward Flying Service Hangers

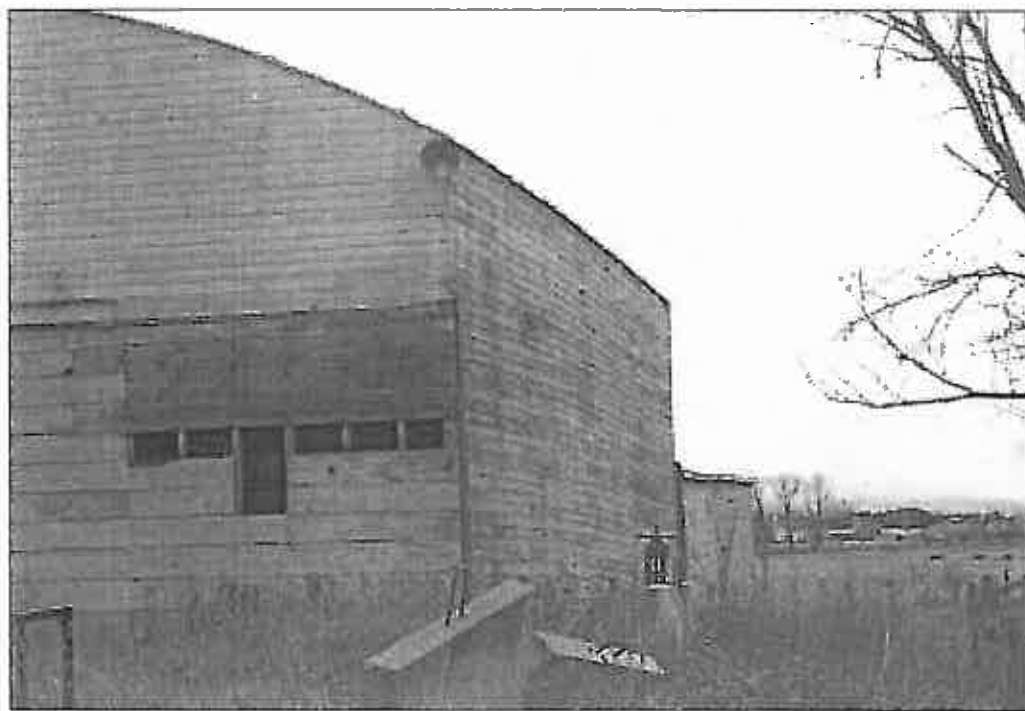
Feature 1, facing south, demonstrating west elevation.

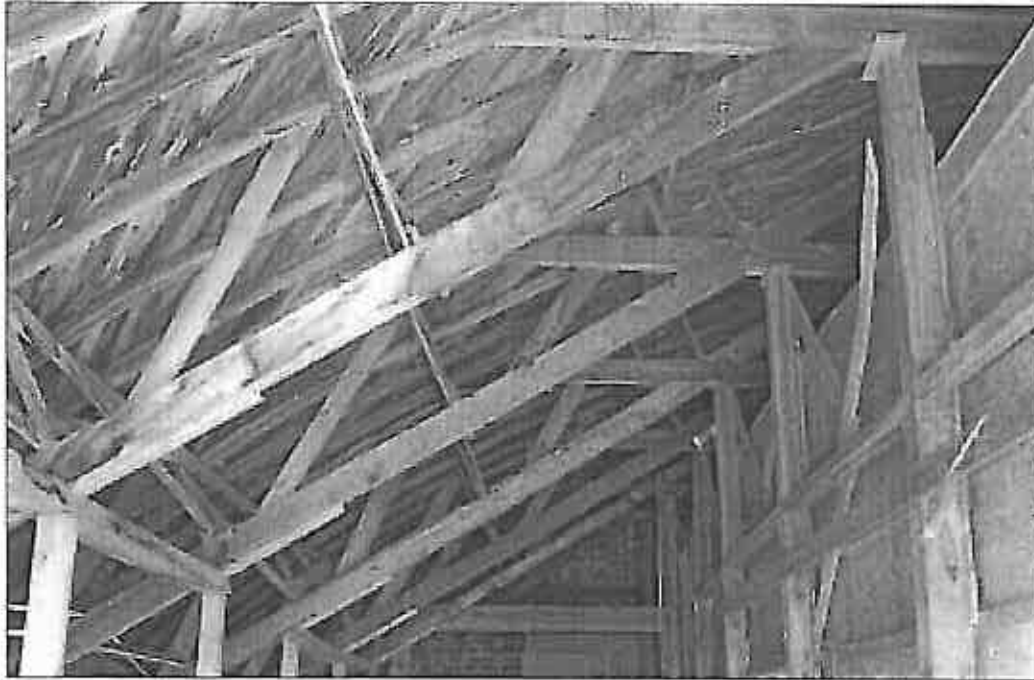
Feature 2, original interior framing and wall alteration (right)

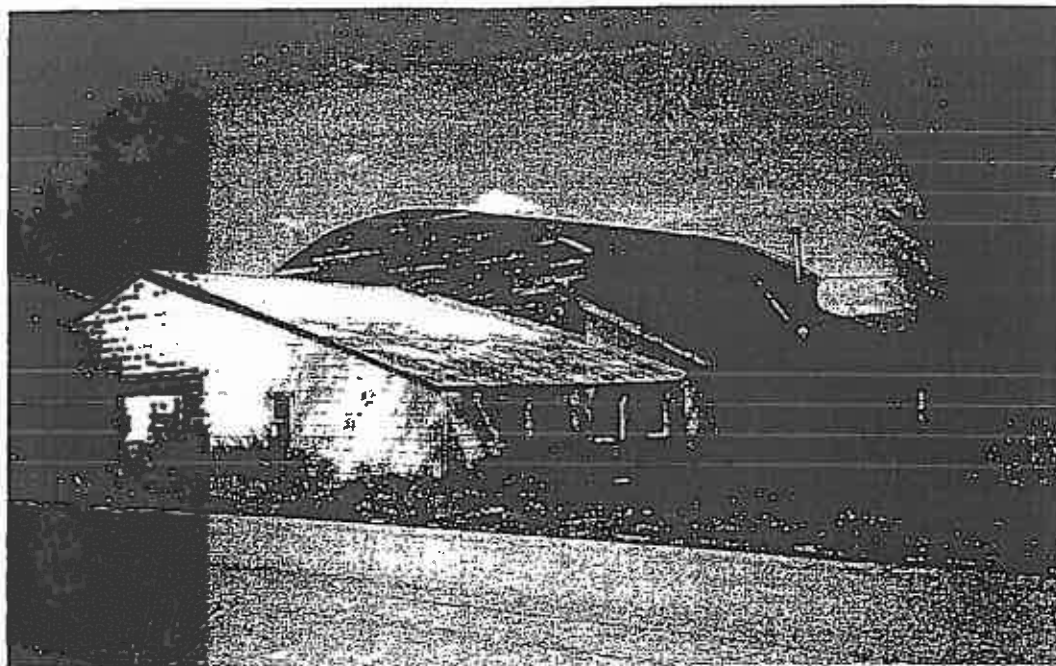
Figure 9. Photo of Hangar 1 (Feature 1) looking northwest.

NRHP Evaluation: The hangars are barely of historic age and both structures have modern additions and modifications. Neither function in their original capacity. Therefore, the architectural and contextual integrity of the site is evaluated as low. The site is not associated with a person or event of historical significance. Neither structure has architectural significance or is likely to yield information important to local history. The site is recommended as not eligible for the NRHP under any criteria.

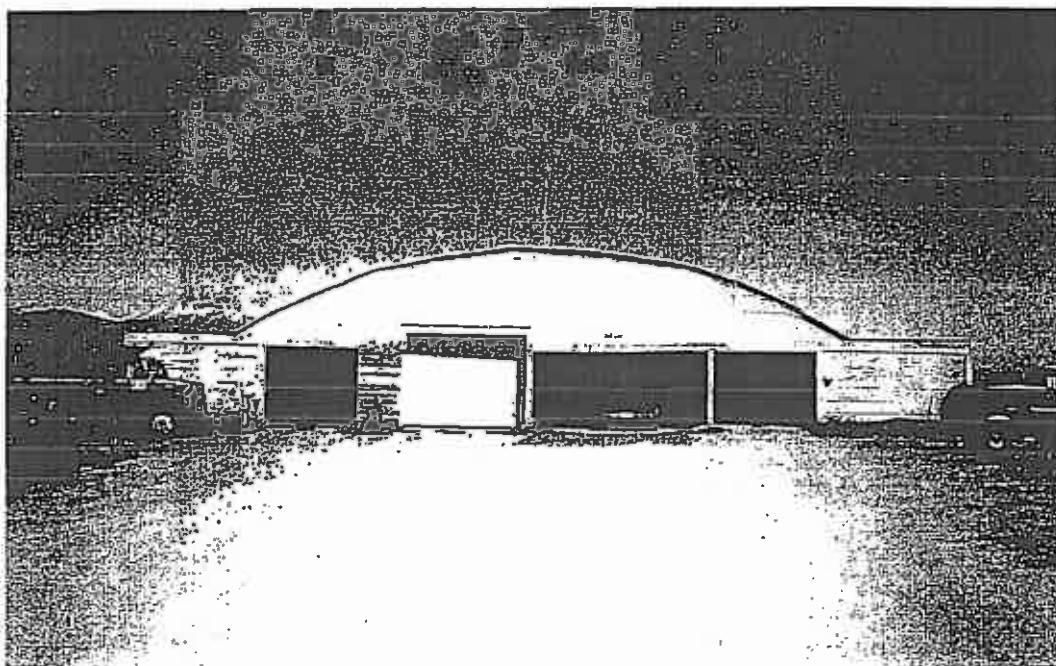
Figure 10. Photo of Hangar 2 (F2) looking north (the office of the Daly Ditches Irrigation District)

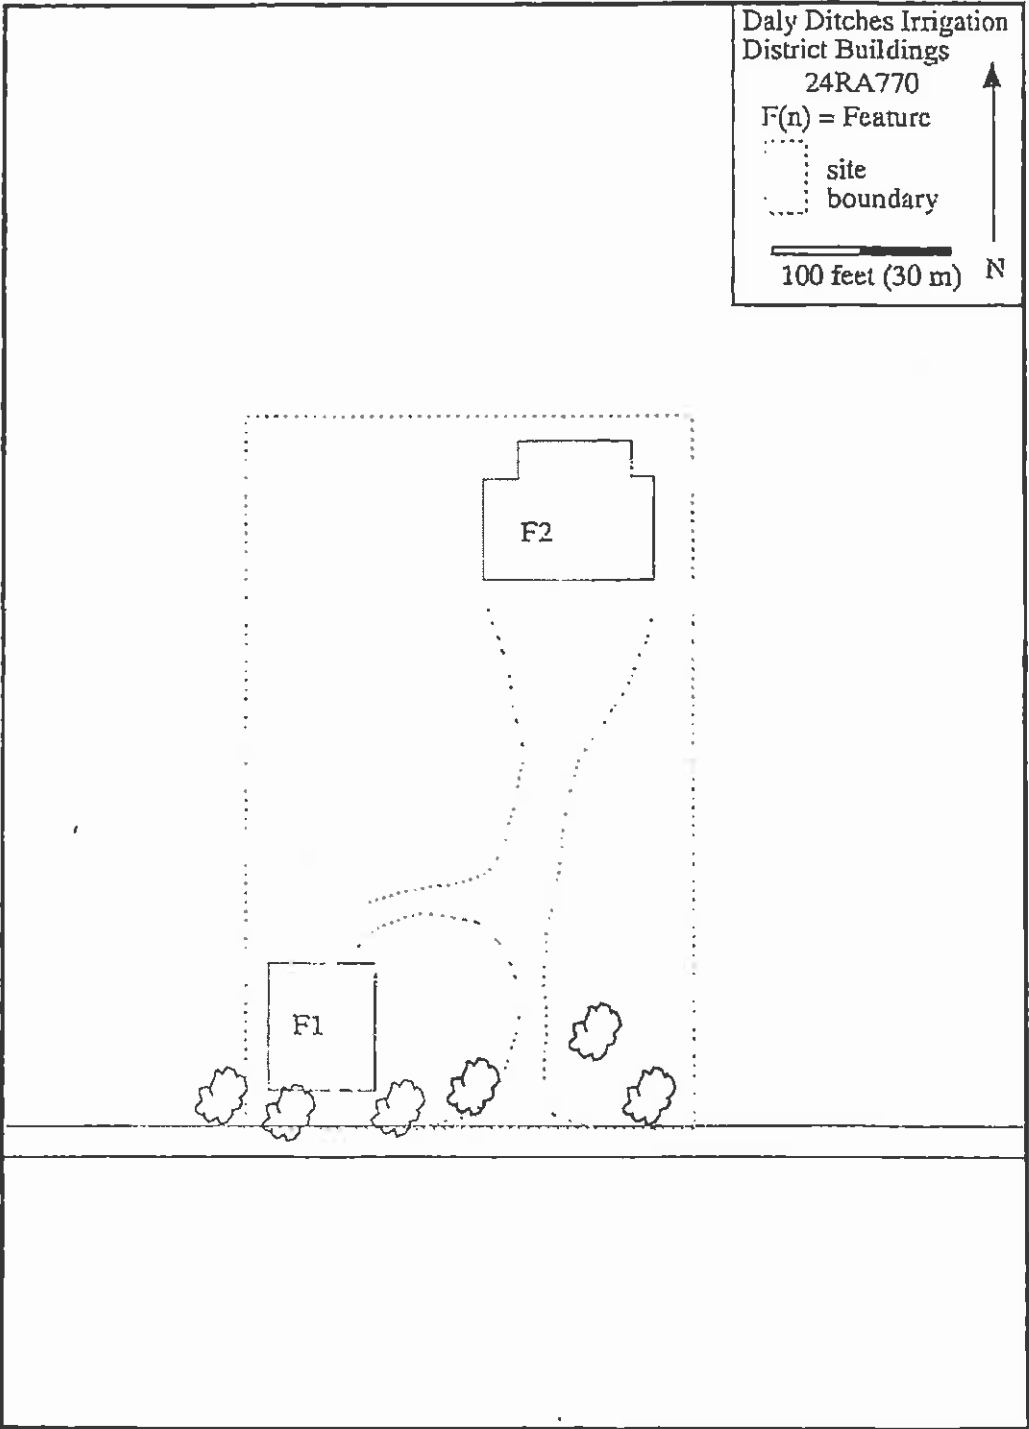
Figure 11. Sketch map of Site 24RA770

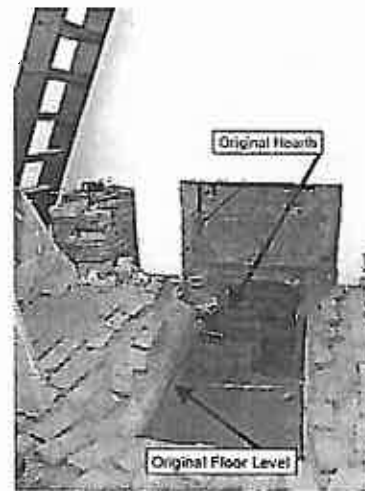
Archeological studies may be valuable in uncovering important evidence of changes to a historic structure. Following historical research and after several archeological soil probes, a decision was made to excavate an area in front of a mid-nineteenth century fireplace, revealing the original dirt floor and hearth undetected by earlier restoration efforts. Photo: NPS files.

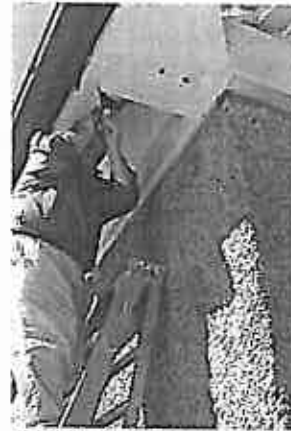
Paint studies may not only help establish the chronology of paints and paint colors used on a building but also may aid in the dating of existing architectural features. Examination of the paint layers on these modillions utilizing a hand-held microscope enabled an investigating team to confirm in the field which modillions were original and which were later replacements. Photo: NPS files.

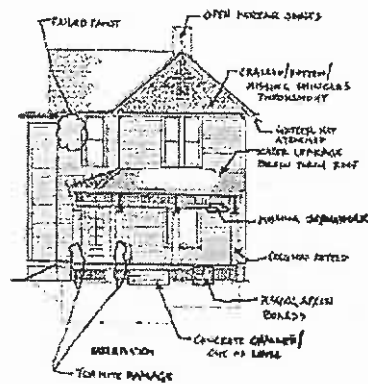
This is one of the measured drawings for the Noland House (see above, left). Drawing: Bahr, Vermeer & Haecker, Architects Ltd.
